## **An Evaluation of Exposure to Mercury Vapor while using Air Cycle's "Bulb Eater" Model 55 VRS**

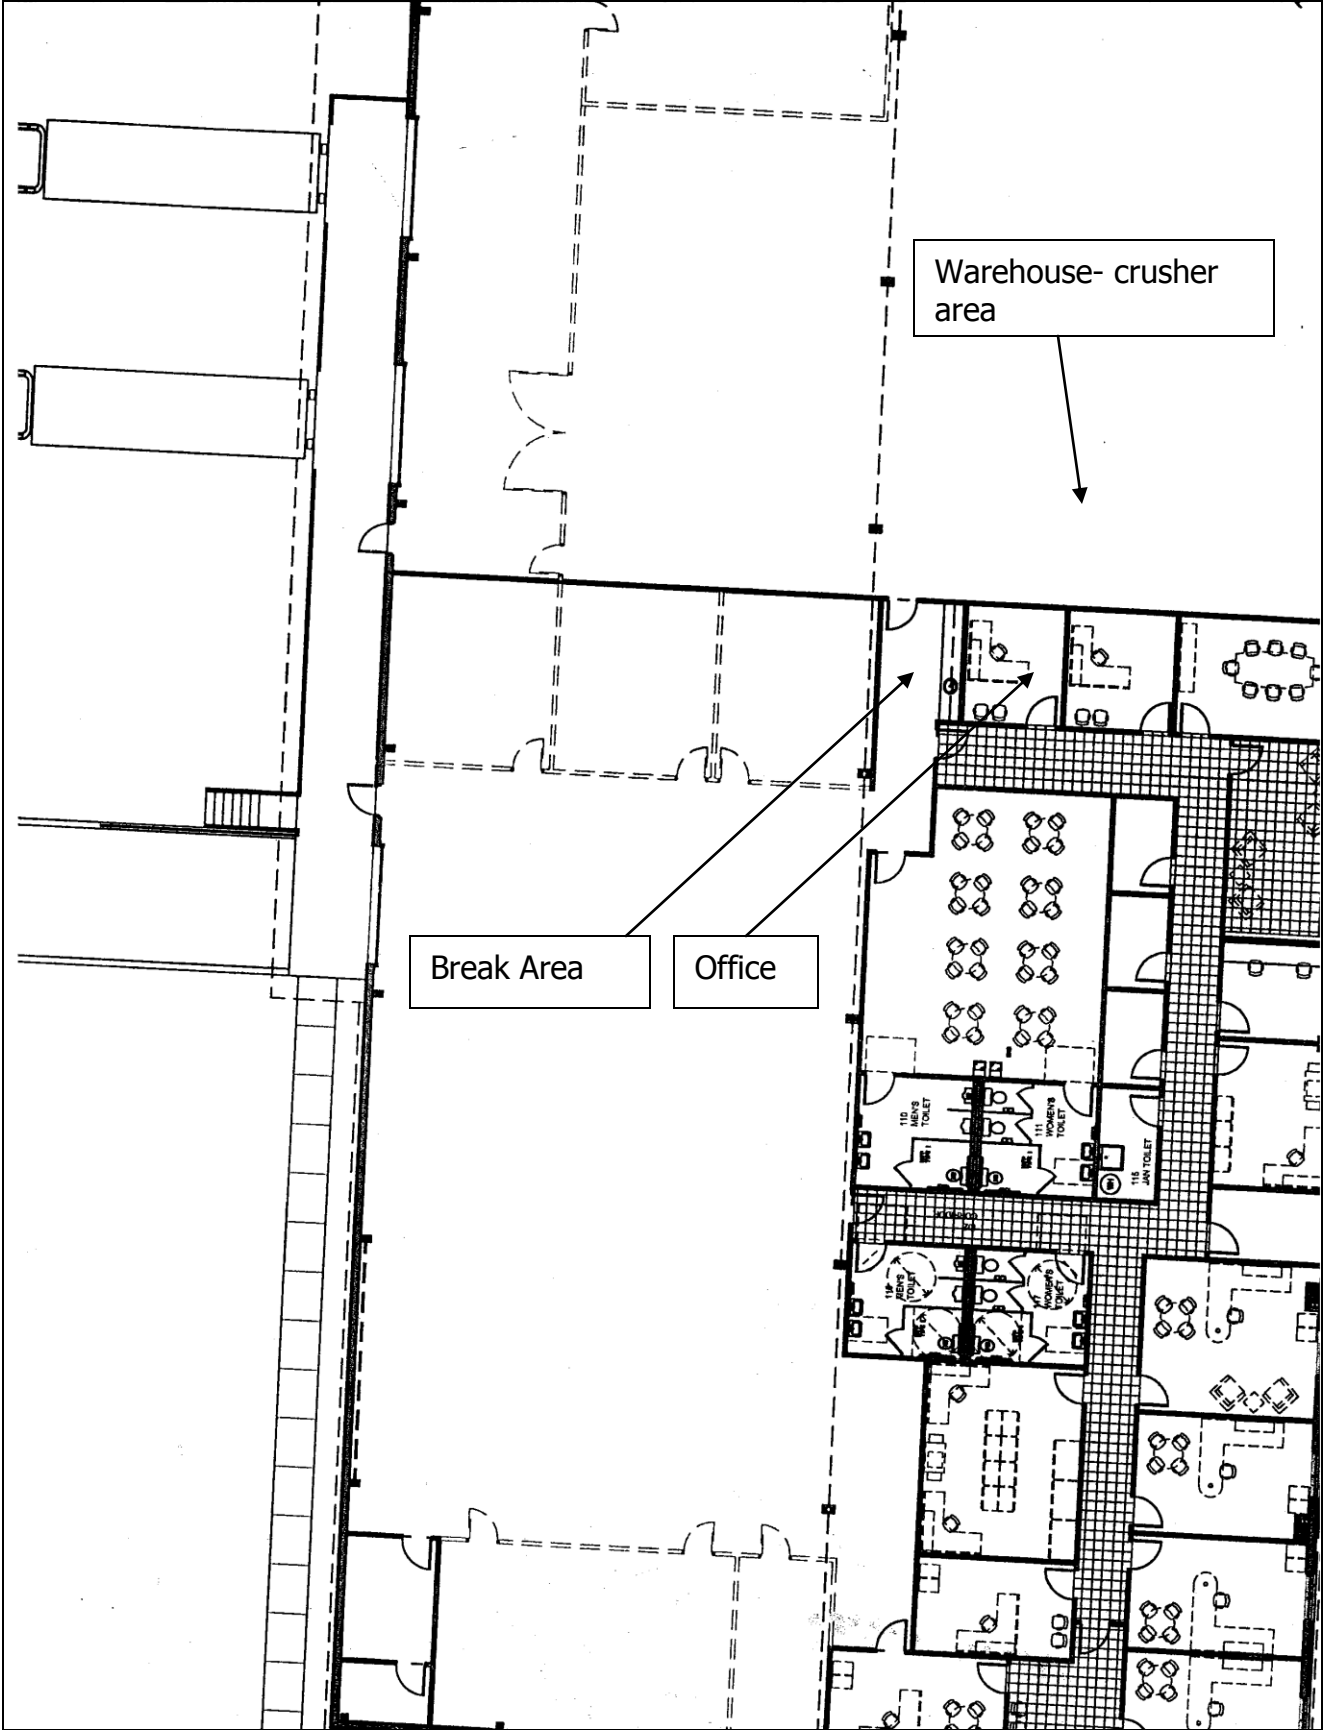
Diagram One

The Bulb Eater is operated in a combination warehouse/office structure (see diagram 1). Three areas within the structure are believed to be affected by operating the Bulb Eater. These areas were evaluated using a Lumex RA-915+ Mercury Vapor Analyzer. The Lumex unit was calibrated in February, 2006. The three areas are in close proximity to where the Bulb Eater is operated and mercury-containing fluorescent light bulbs are stored. The three areas include:

- *Warehouse Crusher Area:* This is where the Bulb Eater is operated. Temperature and humidity are similar to outdoor conditions.
- *Office:* The office has a small window that opens to allow communication with warehouse employees. This office is a temperature-controlled environment.
- *Break area:* The door to enter the break area is adjacent to the Warehouse Crusher Area. The door is frequently opened and closed while the Bulb Eater is operating. This break area is a temperature-controlled environment.

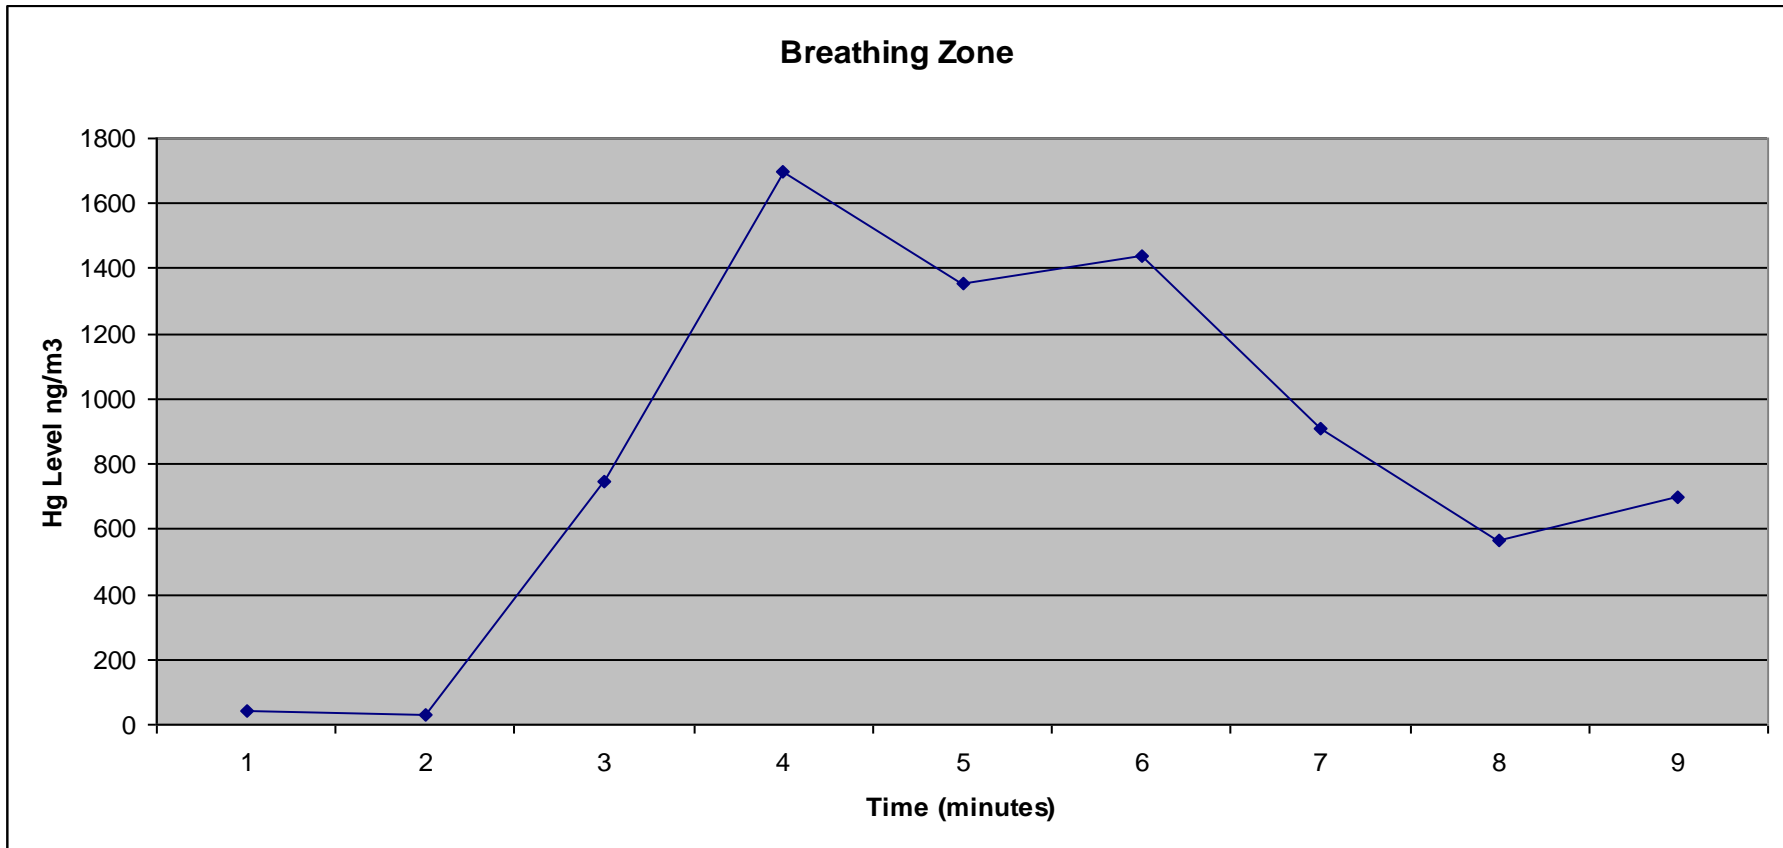
**NOTE:** Nine minutes were required for the operator to crush 60 bulbs. A peak of 1700ng/m<sup>3</sup> was recorded. The average was 831ng/m<sup>3</sup>.
