Inspection Report

Establishment Name		Motor Vehicle Administration			
Site Address	6601 Ritchie Highway, N.E. Glen Burnie, MD 21062	Site Phone	(410) 768-7069	Site Fax	(410) 424-3068
		Other			
Mailing Address	6601 Ritchie Highway, N.E. Glen Burnie, MD 21062	Mail Phone	(410) 768-7069	Mail Fax	(410) 424-3068
		Other			
Controlling Corp	State of Maryland	Employer ID			
Ownership	C. State Government	City	0673	County	003
Legal Entity	Previous Activity (State Only)

A MOSH limited scope inspection was initiated on 08/05/10 by Ms. Cristina Campbell, MOSH Industrial Hygienist as a result of a referral by Maryland Department of Environment regarding possible exposure to mercury from crushing of fluorescent lightbulbs while operating a drum crusher. The inspection was conducted at MVA Headquarters which is located at 6601 Ritchie Highway in Glen Burnie, Maryland.

Photo Mount Worksheet

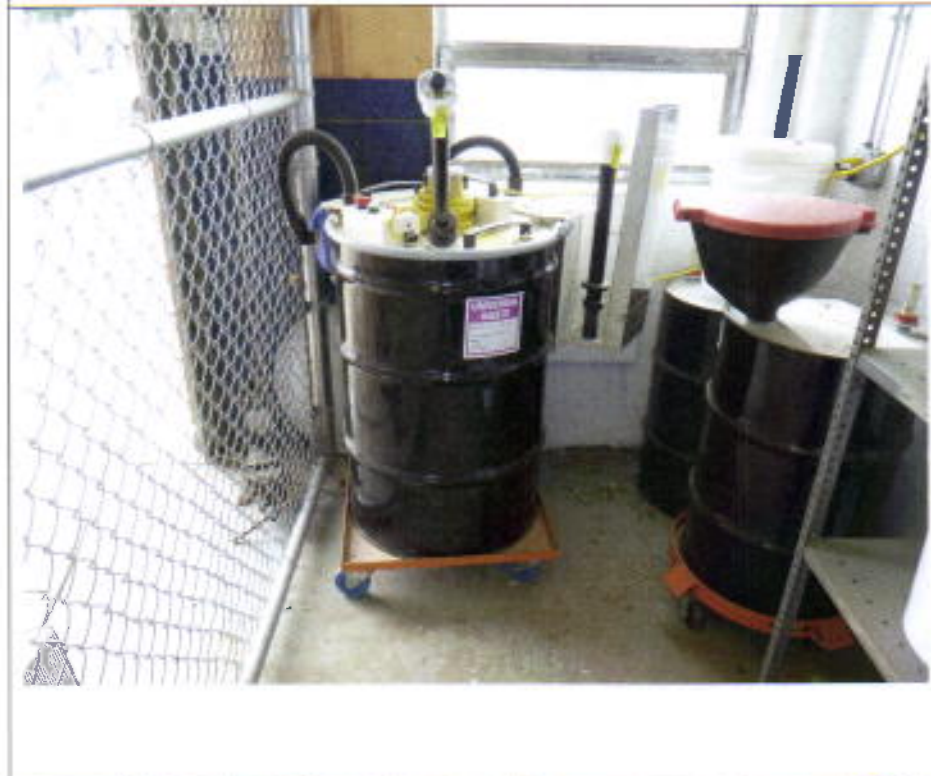
Photo ID #: 1	Date: 08/05/10
------------------	-------------------

Description:
 The Aircycle Bulb Eater® fits onto an empty 55-gallon drum where intact bulbs are fed into the machine and the crushed pieces are collected inside the drum.

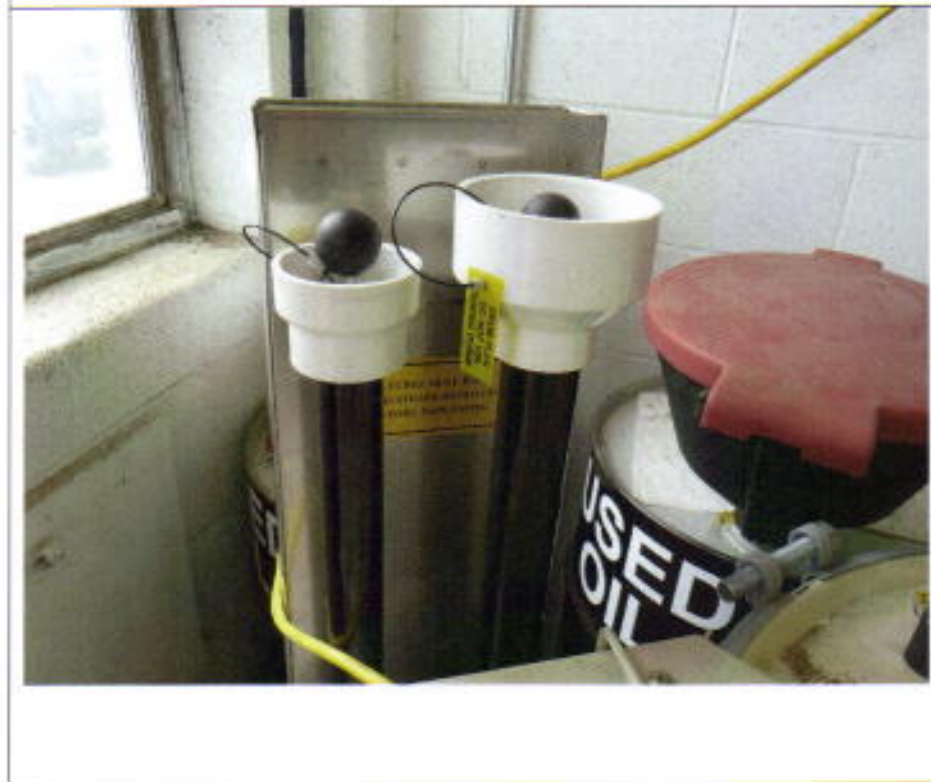
Photo ID #: 2	Date: 08/05/10
------------------	-------------------

Description:
 Several different size entry tubes for feeding the bulbs in the crusher were available for use onsite. Use of the correct size tube helps to maintain the integrity of the lamp throughout the crushing process and minimize external breakage.

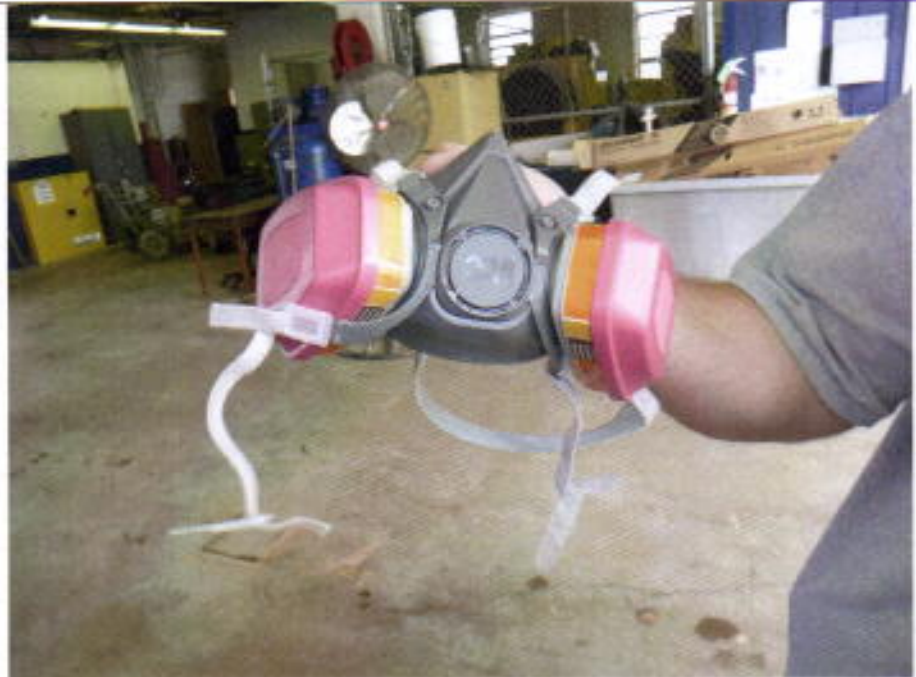
Photo ID #: 3	Date: 08/05/10
------------------	-------------------

Description:
Employees voluntarily wore at 3M 6300 Series half-facepiece respirator with mercury vapor cartridges.

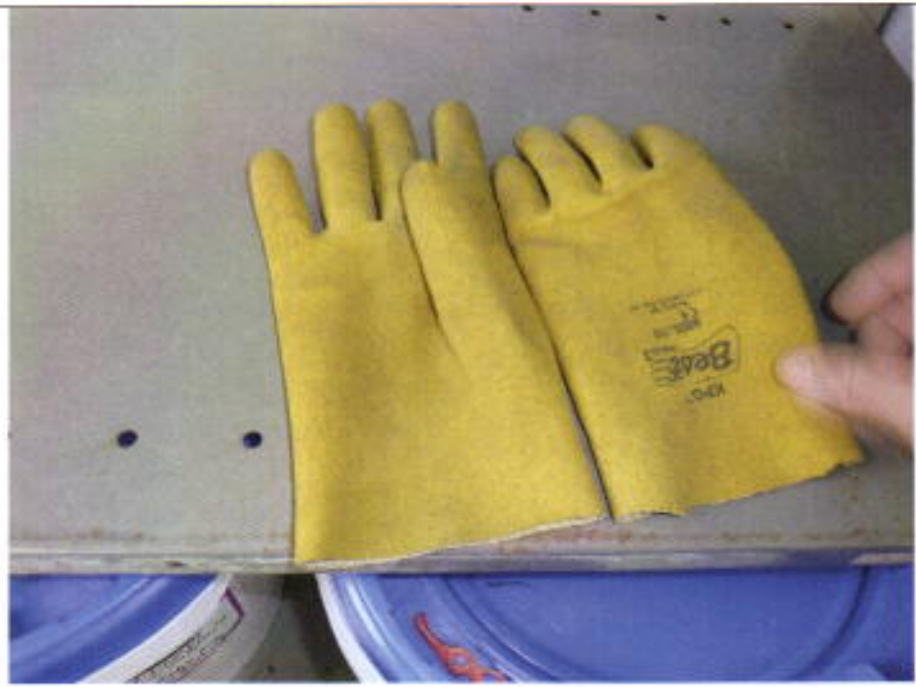
Photo ID #: 4	Date: 08/05/10
------------------	-------------------

Description:
Employees wore safety glasses and PVC-coated gloves when handling fluorescent bulbs or performing maintenance on the bulb crusher.

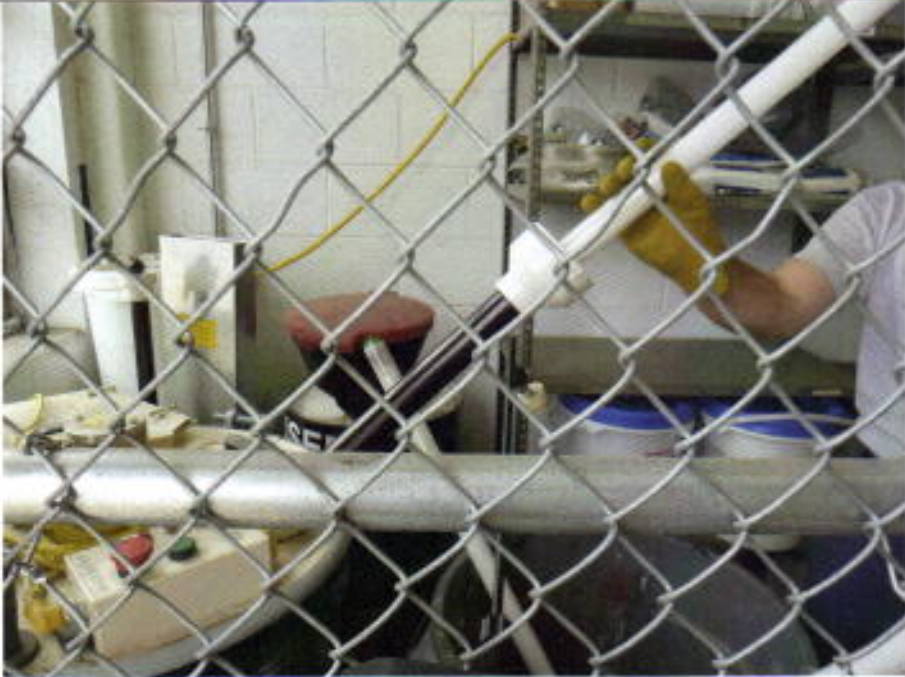
Photo ID #: 5	Date 08/05/10
		Location (Photo & Photographer): Maintenance Building	
		Description: Employees feed bulbs into the crusher via an entry tube. Vacuum suction pulls the bulb into the crusher where the spinner assembly fragments it into small pieces.

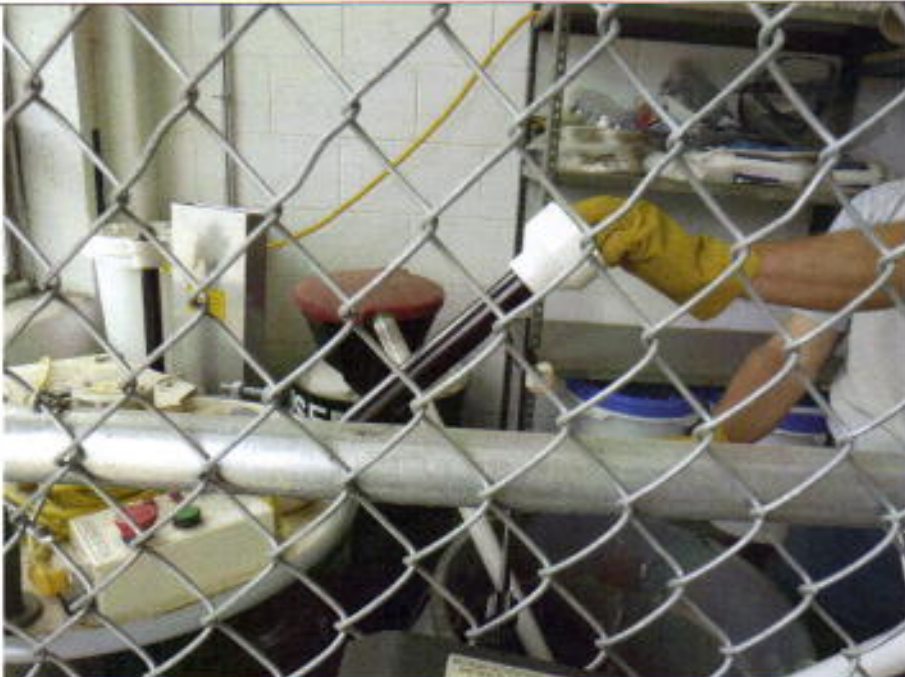
Photo ID #: 6	Date: 08/05/10
		Location (Photo & Photographer): Maintenance Building	
		Description: A long entry tube just wider than the bulb helps prevent the bulbs from breaking before they reach the inside of the crusher. The machine housing is equipped with a safety shut off which prevents the operation of the machine if it is not installed on a drum.

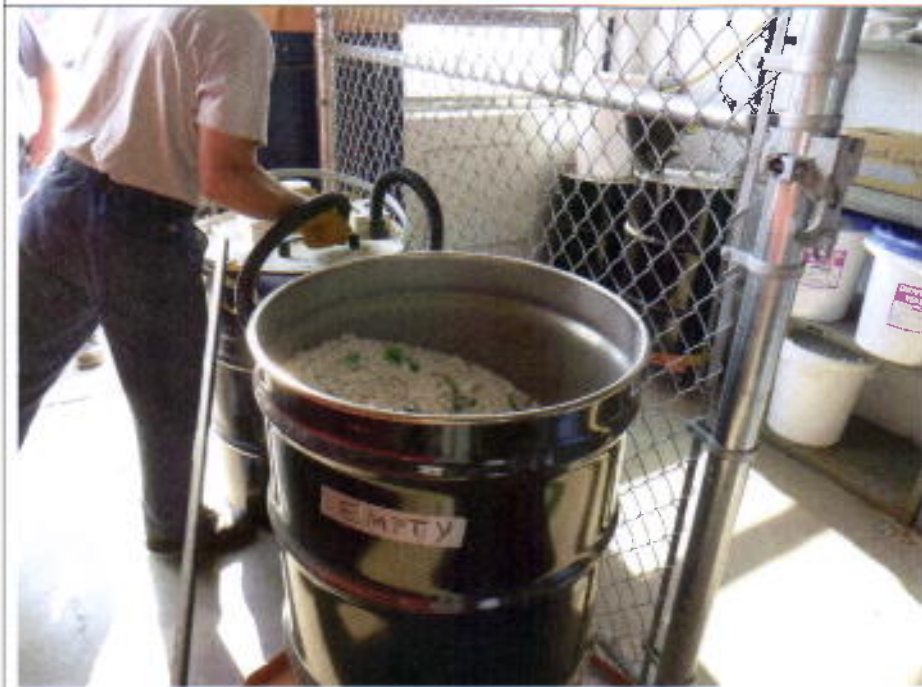
Photo ID #: 7	Date: 08/24/10
------------------	-------------------

When the drum becomes full employees let the drum sit at least overnight and then change the drum by loosening the ring that seals the machine to the drum, lifting the machine off of the full drum, replacing the filter(s), placing onto an empty drum, and replacing and tightening the sealing ring. A lid is then placed and sealed onto the full drum, and the drum is transported by an outside contractor to another facility for disposal.

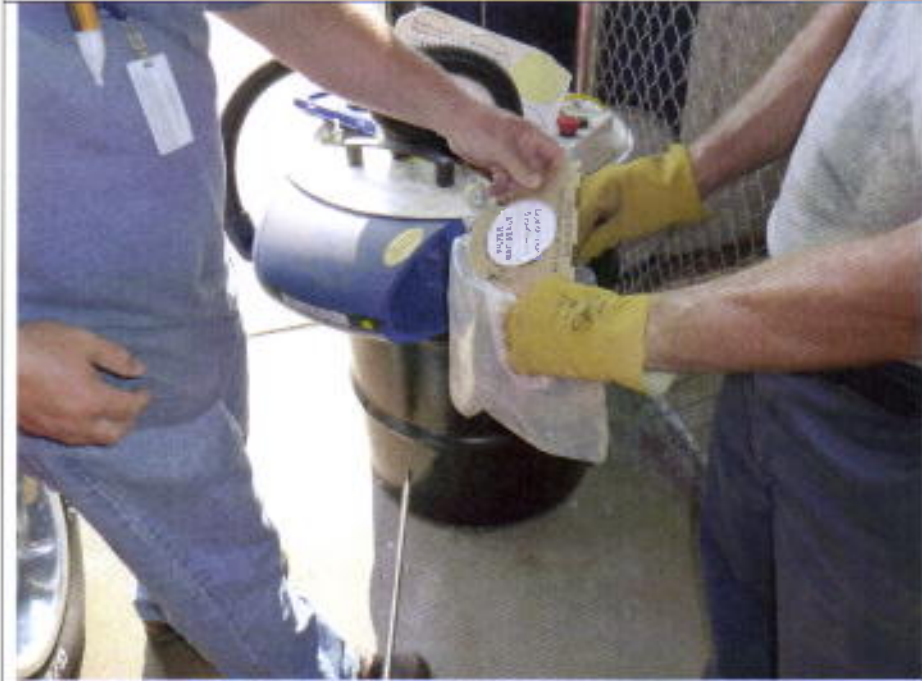
Photo ID #: 8	Date: 08/24/10
------------------	-------------------

Employees seal the filter, remove it from the filter housing, place into a sealable bag, and then place the bag inside the full drum for disposal.
