**Inspection Report**

Establishment Name		Motor Vehicle Administration			
Site Address	6601 Ritchie Highway, N.E. Glen Burnie, MD 21062	Site Phone	(410) 768-7069	Site Fax	(410) 424-3068
		Other			
Mailing Address	6601 Ritchie Highway, N.E. Glen Burnie, MD 21062	Mail Phone	(410) 768-7069	Mail Fax	(410) 424-3068
		Other			
Controlling Corp	State of Maryland	Employer ID			
Ownership	C. State Government	City	0673	County	003
Legal Entity		Previous Activity (State Only)

A MOSH limited scope inspection was initiated on 08/05/10 by Ms. Cristina Campbell, MOSH Industrial Hygienist as a result of a referral by Maryland Department of Environment regarding possible exposure to mercury from crushing of fluorescent lightbulbs while operating a drum crusher. The inspection was conducted at MVA Headquarters which is located at 6601 Ritchie Highway in Glen Burnie, Maryland.

**Photo Mount Worksheet**

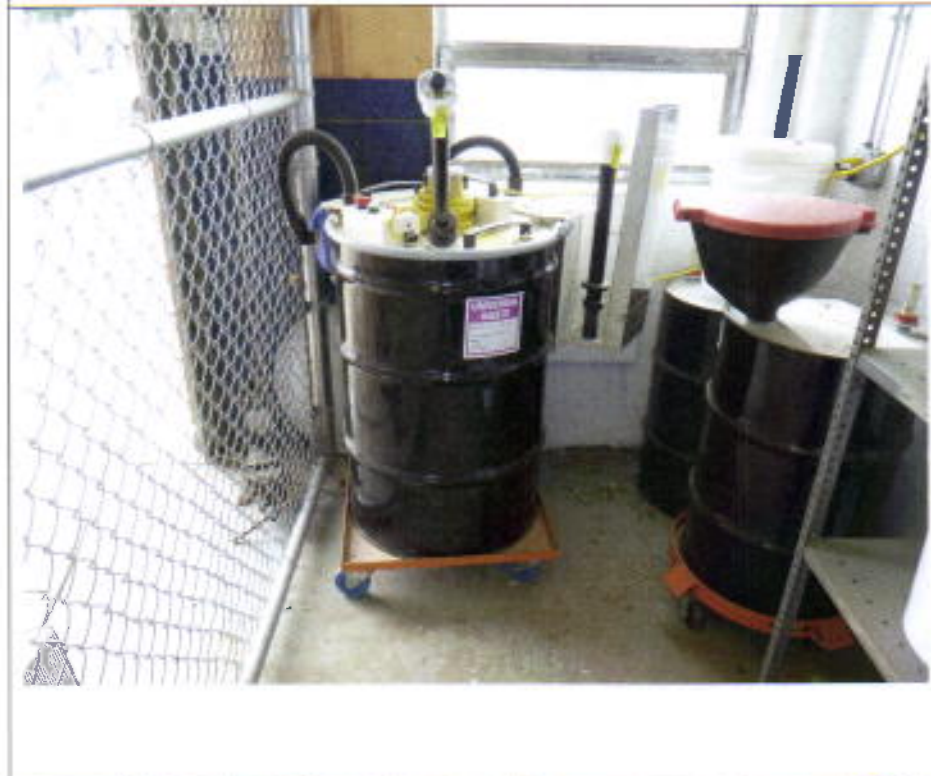
Photo ID #: 1	Date: 08/05/10
------------------	-------------------

The Aircycle Bulb Eater® fits onto an empty 55-gallon drum where intact bulbs are fed into the machine and the crushed pieces are collected inside the drum.

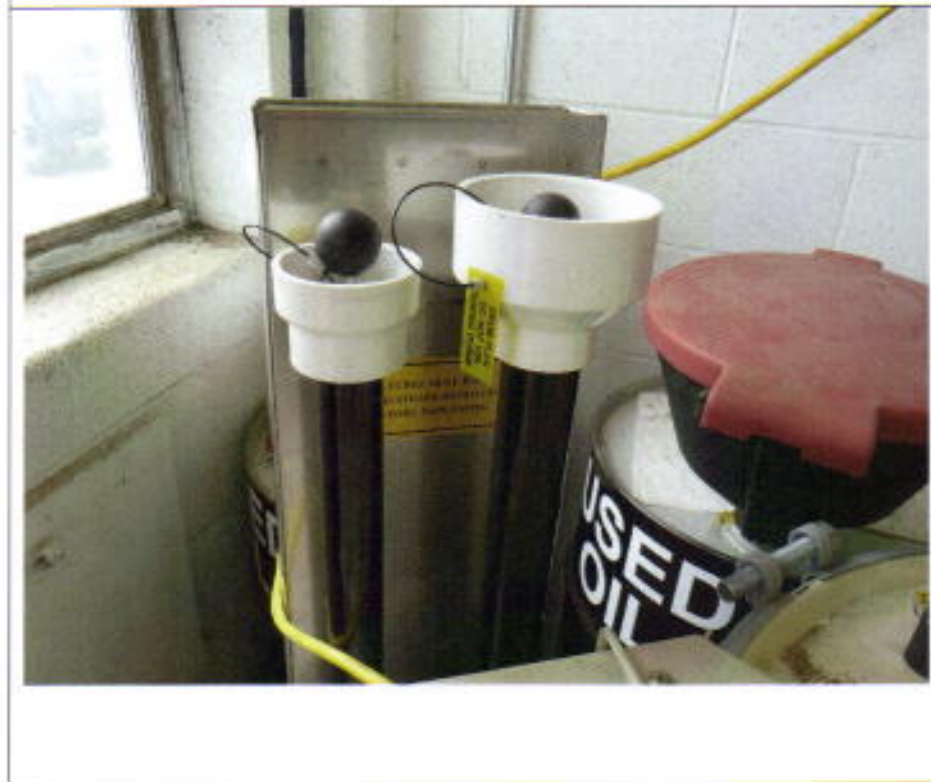
Photo ID #: 2	Date: 08/05/10
------------------	-------------------

Several different size entry tubes for feeding the bulbs in the crusher were available for use onsite. Use of the correct size tube helps to maintain the integrity of the lamp throughout the crushing process and minimize external breakage.

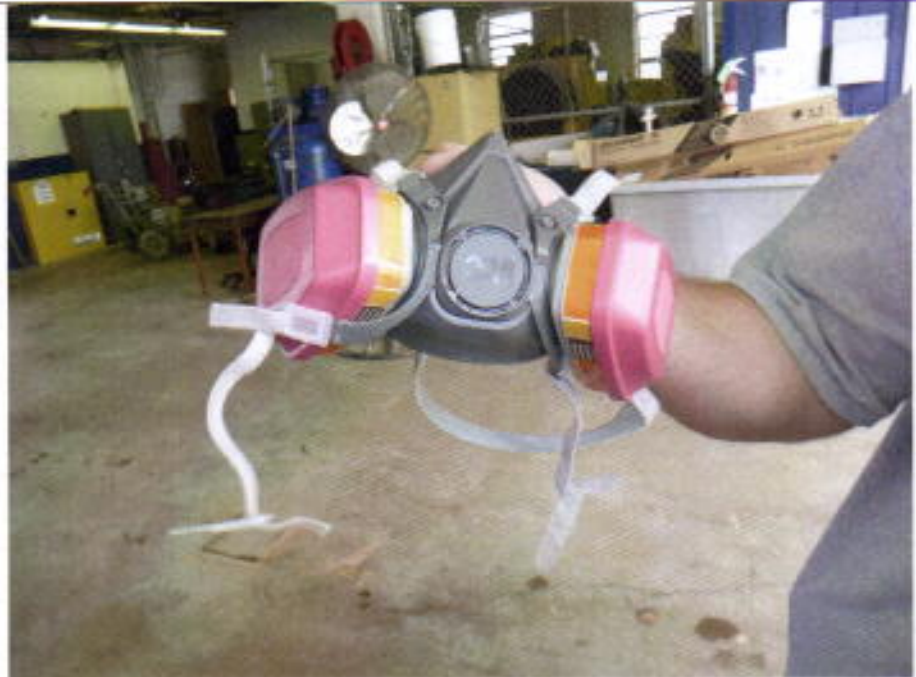
Photo ID #: 3	Date: 08/05/10
------------------	-------------------

Description:  
Employees voluntarily wore at 3M 6300 Series half-facepiece respirator with mercury vapor cartridges.

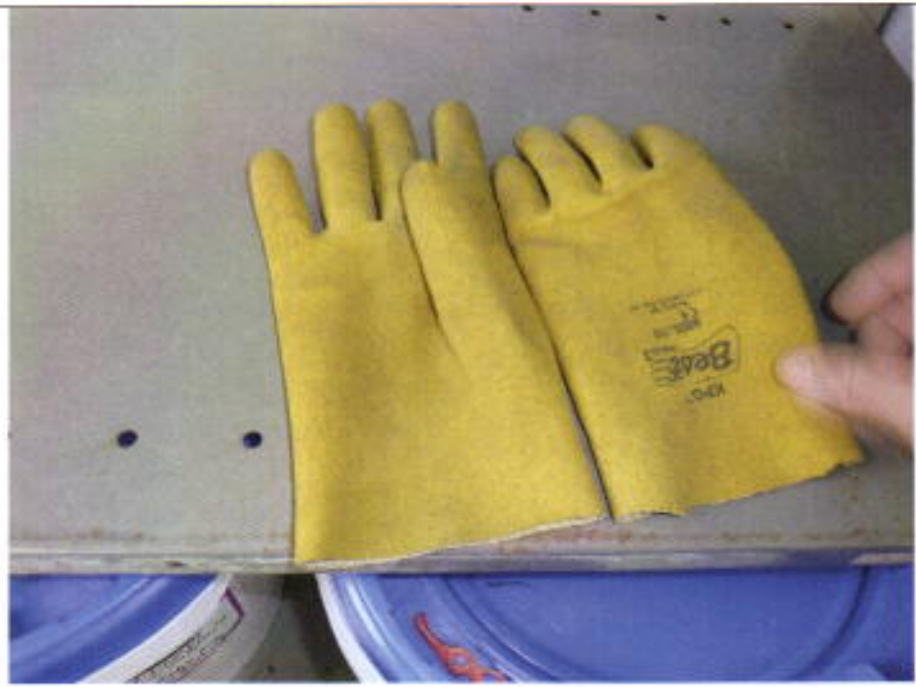
Photo ID #: 4	Date: 08/05/10
------------------	-------------------

Description:  
Employees wore safety glasses and PVC-coated gloves when handling fluorescent bulbs or performing maintenance on the bulb crusher.

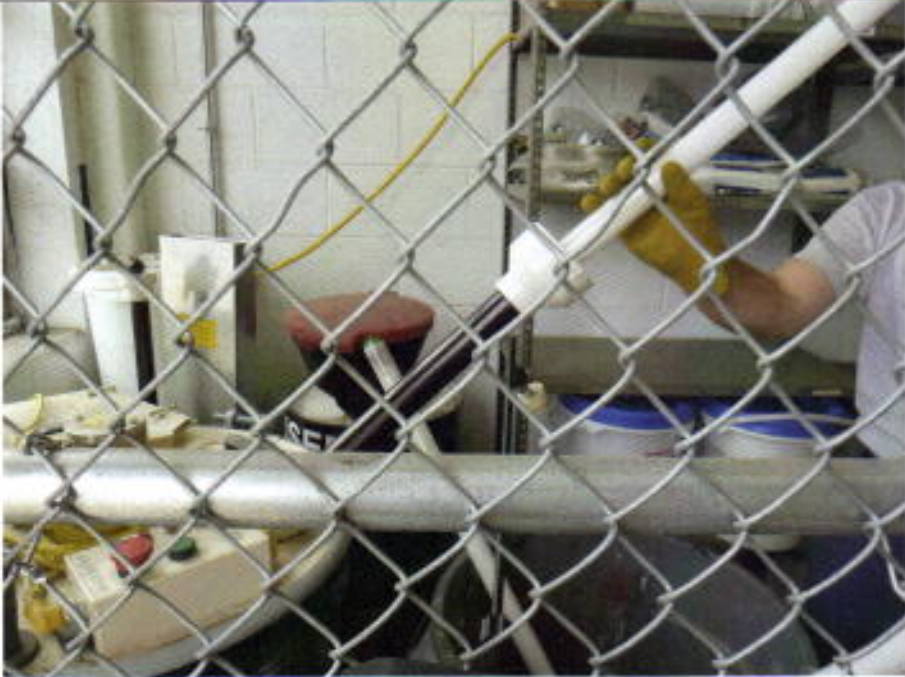
Photo ID #: 5	Date 08/05/10
		Location (Photo & Photographer): Maintenance Building	
		Description:  Employees feed bulbs into the crusher via an entry tube. Vacuum suction pulls the bulb into the crusher where the spinner assembly fragments it into small pieces.

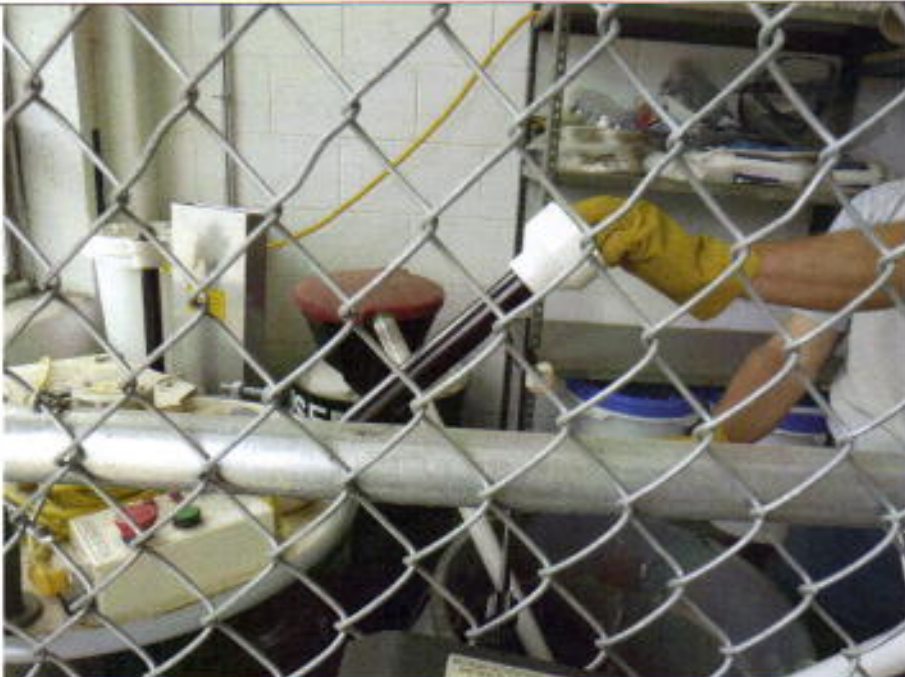
Photo ID #: 6	Date: 08/05/10
		Location (Photo & Photographer): Maintenance Building	
		Description:  A long entry tube just wider than the bulb helps prevent the bulbs from breaking before they reach the inside of the crusher. The machine housing is equipped with a safety shut off which prevents the operation of the machine if it is not installed on a drum.

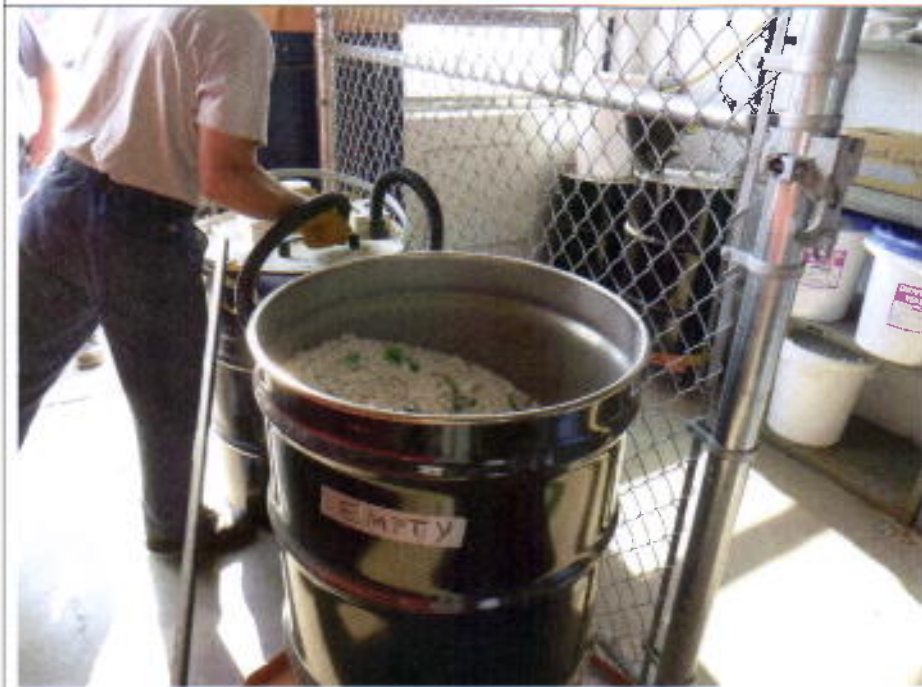
Photo ID #: 7	Date: 08/24/10
------------------	-------------------

When the drum becomes full employees let the drum sit at least overnight and then change the drum by loosening the ring that seals the machine to the drum, lifting the machine off of the full drum, replacing the filter(s), placing onto an empty drum, and replacing and tightening the sealing ring. A lid is then placed and sealed onto the full drum, and the drum is transported by an outside contractor to another facility for disposal.

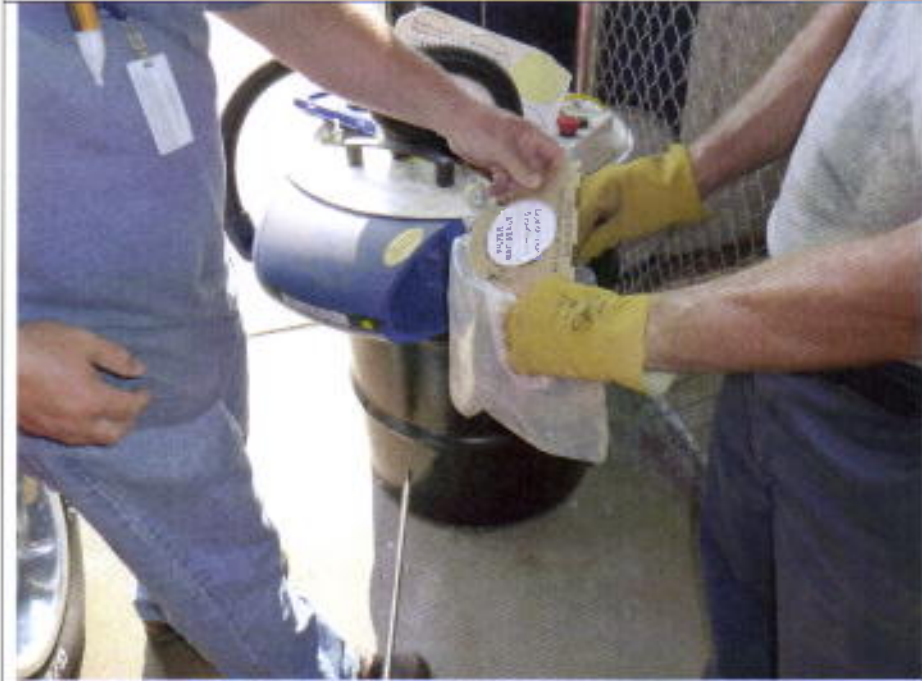
Photo ID #: 8	Date: 08/24/10
------------------	-------------------

Employees seal the filter, remove it from the filter housing, place into a sealable bag, and then place the bag inside the full drum for disposal.
